**Flood Control Project Maintenance
Levee Inspections**
LMA District Cover Sheet
Spring 2016 Levee Inspection Results

American River Flood Control District

Spring 2016 Levee Inspection Results

Waterway			Bank	Unit Miles
Unit No. 01 Arcade Creek			Left	2.08
	Spring (March - May)	Summer (June - August)	(September - November) Fall	Winter (December - February)
Unit Maintenance Rating (Fall Only)				
Date of Inspection	3/2/2016 - 3/2/2016			
DWR Inspector	Maksim Khashchuk			
Accompanied By	Richard Marck ARFCD			
	Sterling York

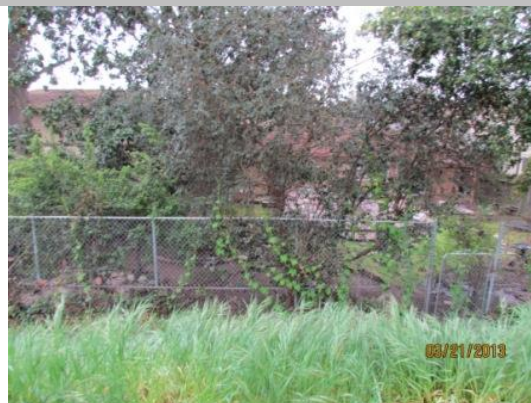
Photo 1 of 1 : SP_2016_NA0001_55_122_20160229_00105.jpg

LM Start	9.55	Rating **	M	Issue No.	122
LM End	9.55	Issue Type +	En	Location *	LS
Category	Earthen Levee			GPS Latitude/Longitude	
				Start	End
Item	Vegetation			38.567181 °	38.567181 °
				-121.370366 °	-121.370366 °
DWR ID	DWR_NA0001_04_s_2012_122				
Comment Code					
V6 : Landscaping					
Inspector Comment					
Trees and ground cover within 10-ft of levee toe.

View of landscaping at levee toe.

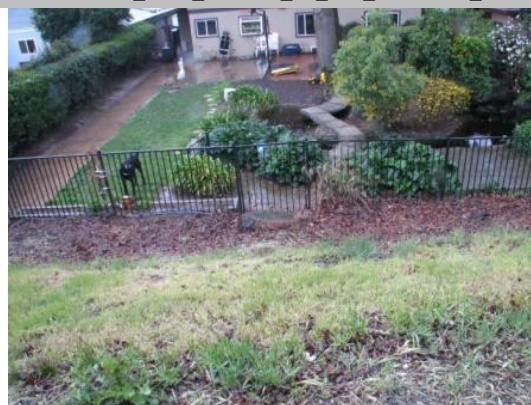
Photo 1 of 1 : SP_2016_NA0001_55_123_20160229_00106.jpg

LM Start	9.57	Rating **	N	Issue No.	123
LM End	9.57	Issue Type +	Ma	Location *	LS
Category	Earthen Levee			GPS Latitude/Longitude	
				Start	End
Item	Trim / Thin Trees			38.567285 °	38.567285 °
				-121.369964 °	-121.369964 °
DWR ID	DWR_NA0001_04_s_2012_123				
Comment Code					
T5 : Tree stumps.					
Inspector Comment					
Trees, bushes and ground cover within 10-ft of levee toe.

03/16/2012 Large tree stump at levee toe.

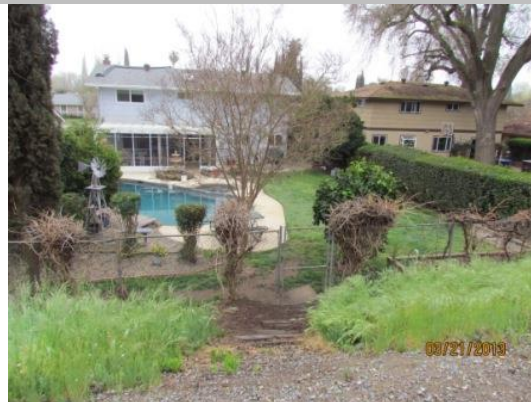
Photo 1 of 1 : SP_2016_NA0001_55_124_20160229_00107.jpg

LM Start	9.58	Rating **	M	Issue No.	124
LM End	9.58	Issue Type +	En	Location *	LS
Category	Earthen Levee			GPS Latitude/Longitude	
				Start	End
Item	Vegetation			38.567242 °	38.567242 °
				-121.369858 °	-121.369858 °
DWR ID	DWR_NA0001_04_s_2012_124				
Comment Code					
V6 : Landscaping					
Inspector Comment					
Ivy and vines on chain link fence within 10-ft of levee toe.

View of landscaping at levee toe.

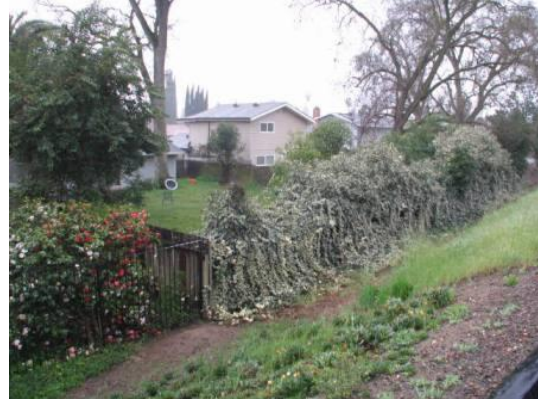
Photo 1 of 1 : SP_2016_NA0001_55_125_20160229_00108.jpg

LM Start	9.60	Rating **	U	Issue No.	125
LM End	9.60	Issue Type +	En	Location *	LS
Category	Earthen Levee			GPS Latitude/Longitude	
				Start	End
Item	Vegetation			38.567360 °	38.567360 °
				-121.369555 °	-121.369555 °
DWR ID	DWR_NA0001_04_s _ 2012_125				
Comment Code					
V6 : Landscaping					
Inspector Comment					
Dense golden ivy on C/L fence obstructs access and visibility.

03/16/2012 Landscaping obstructs visibility and access.

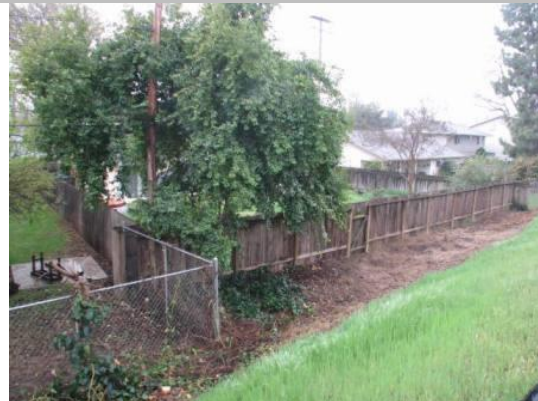
Photo 1 of 1 : SP_2016_NA0001_55_128_20160229_00109.jpg

LM Start	9.65	Rating **	U	Issue No.	128
LM End	9.65	Issue Type +	En	Location *	LS
Category	Earthen Levee			GPS Latitude/Longitude	
				Start	End
Item	Encroachments			38.567493 °	38.567493 °
				-121.368633 °	-121.368633 °
DWR ID	DWR_NA0001_04_s _ 2012_128				
Comment Code					
FE : Fence					
Inspector Comment					
Wooden privacy fence within 10-ft of levee toe.

03/16/2012 Wood privacy fence completely obstructs access and visibility.

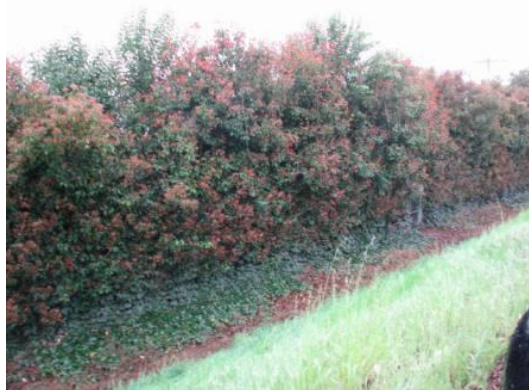
Photo 1 of 1 : SP_2016_NA0001_55_130_20160229_00111.jpg

LM Start	9.69	Rating **	U	Issue No.	130
LM End	9.69	Issue Type +	En	Location *	LS
Category	Earthen Levee			GPS Latitude/Longitude	
				Start	End
Item	Vegetation			38.567626 °	38.567626 °
				-121.367921 °	-121.367921 °
DWR ID	DWR_NA0001_04_s_2012_130				
Comment Code					
V6 : Landscaping					
Inspector Comment					
Tall hedge obstructs access and visibility.

03/16/2012 Tall hedge obstructs visibility and access.

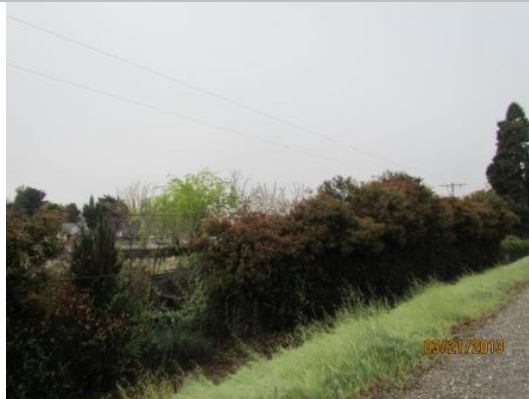
Photo 1 of 1 : SP_2016_NA0001_55_131_20160229_00112.jpg

LM Start	9.70	Rating **	M	Issue No.	131
LM End	9.70	Issue Type +	En	Location *	LS
Category	Earthen Levee			GPS Latitude/Longitude	
				Start	End
Item	Vegetation			38.567680 °	38.567680 °
				-121.367674 °	-121.367674 °
DWR ID	DWR_NA0001_04_s_2012_131				
Comment Code					
V6 : Landscaping					
Inspector Comment					
Tall hedge obstructs access and visibility.

View of landscaping at levee toe.

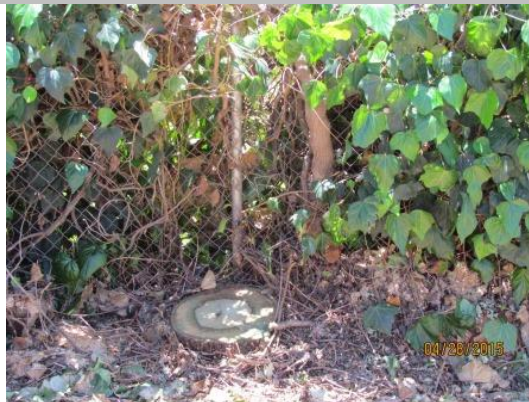
Photo 1 of 1 : SP_2016_NA0001_55_234_20160229_00181.jpg

LM Start	9.72	Rating **	N	Issue No.	234
LM End	9.72	Issue Type +	Ma	Location *	LS
Category	Earthen Levee			GPS Latitude/Longitude	
				Start	End
Item	Trim / Thin Trees			38.567761 °	38.567761 °
				-121.367363 °	-121.367363 °
DWR ID	DWR_NA0001_04_s_2015_234				
Comment Code					
T5 : Tree stumps.					
Inspector Comment

View of the tree stump at the landside levee toe.

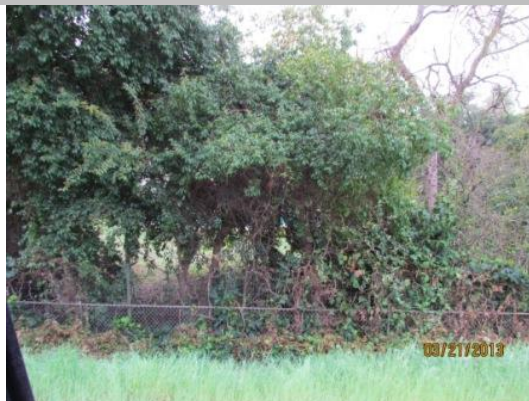
Photo 1 of 1 : SP_2016_NA0001_55_132_20160229_00113.jpg

LM Start	9.72	Rating **	M	Issue No.	132
LM End	9.72	Issue Type +	En	Location *	LS
Category	Earthen Levee			GPS Latitude/Longitude	
				Start	End
Item	Vegetation			38.567772 °	38.567772 °
				-121.367227 °	-121.367227 °
DWR ID	DWR_NA0001_04_s _ 2012_132				
Comment Code					
V6 : Landscaping					
Inspector Comment					
Trees and ivy on levee slope obstruct access and visibility.

View of obstructive landscaping.

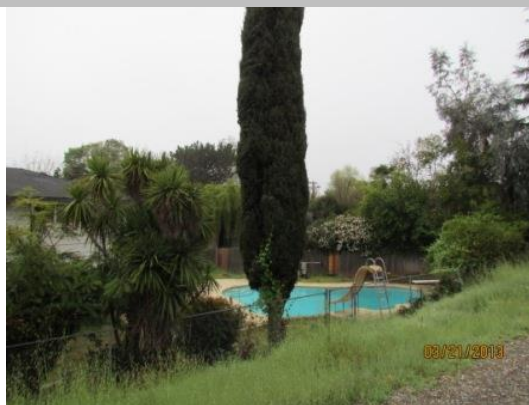
Photo 1 of 1 : SP_2016_NA0001_55_133_20160229_00114.jpg

LM Start	9.74	Rating **	M	Issue No.	133
LM End	9.74	Issue Type +	En	Location *	LS
Category	Earthen Levee			GPS Latitude/Longitude	
				Start	End
Item	Vegetation			38.567856 °	38.567856 °
				-121.366892 °	-121.366892 °
DWR ID	DWR_NA0001_04_s _ 2012_133				
Comment Code					
V6 : Landscaping					
Inspector Comment					
Lemon tree, palm, sky pencil and ivy planted within 10-ft of levee toe obstructs access and visibility.

View of landscaping at levee toe.

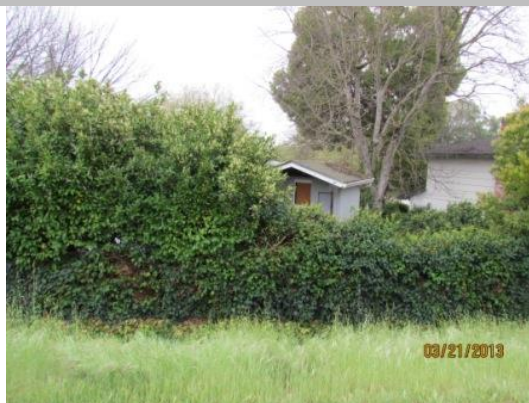
Photo 1 of 1 : SP_2016_NA0001_55_134_20160229_00115.jpg

LM Start	9.77	Rating **	U	Issue No.	134
LM End	9.77	Issue Type +	En	Location *	LS
Category	Earthen Levee			GPS Latitude/Longitude	
				Start	End
Item	Vegetation			38.567873 °	38.567873 °
				-121.366410 °	-121.366410 °
DWR ID	DWR_NA0001_04_s _ 2012_134				
Comment Code					
V6 : Landscaping					
Inspector Comment					
Ivy, hedge and play house is within 10-ft of levee toe.

View of landscaping and playhouse.

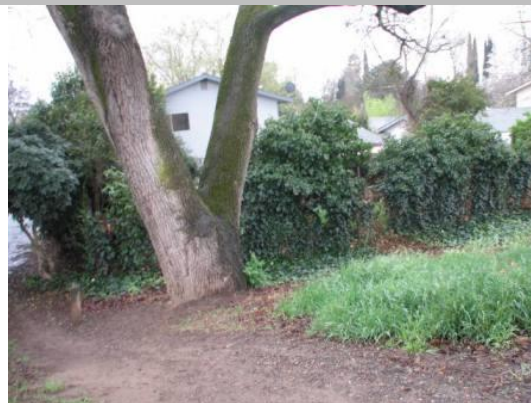
Photo 1 of 1 : SP_2016_NA0001_55_135_20160229_00116.jpg

LM Start	9.89	Rating **	U	Issue No.	135
LM End	9.89	Issue Type +	En	Location *	LS
Category	Earthen Levee			GPS Latitude/Longitude	
				Start	End
Item	Vegetation			38.568446 °	38.568446 °
				-121.364385 °	-121.364385 °
DWR ID	DWR_NA0001_04_s_2012_135				
Comment Code					
V6 : Landscaping					
Inspector Comment					
Tall hedge and ivy within 10-ft of landside levee toe.

03/16/2012 Landscaping is obstructing visibility.

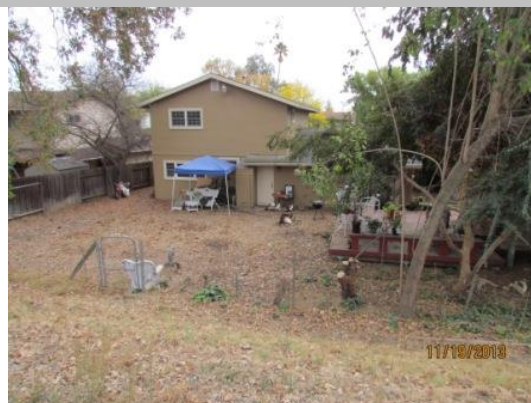
Photo 1 of 1 : SP_2016_NA0001_55_136_20160229_00117.jpg

LM Start	9.95	Rating **	M	Issue No.	136
LM End	9.95	Issue Type +	En	Location *	LS
Category	Earthen Levee			GPS Latitude/Longitude	
				Start	End
Item	Encroachments			38.568714 °	38.568714 °
				-121.363257 °	-121.363257 °
DWR ID	DWR_NA0001_04_s_2012_136				
Comment Code					
FE : Fence					
Inspector Comment					
Wire fence within 10-ft of landside levee toe.

View of the fence and tree stump at the landside levee toe.

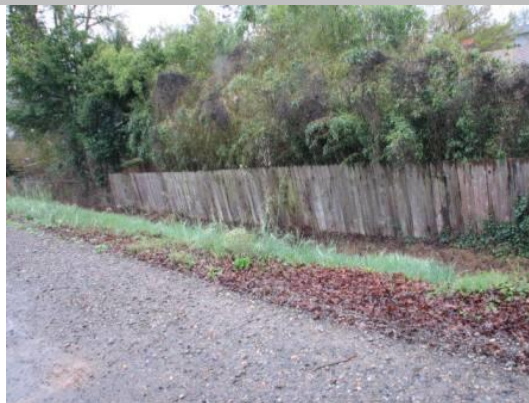
Photo 1 of 1 : SP_2016_NA0001_55_138_20160229_00118.jpg

LM Start	10.00	Rating **	U	Issue No.	138
LM End	10.00	Issue Type +	En	Location *	LS
Category	Earthen Levee			GPS Latitude/Longitude	
				Start	End
Item	Encroachments			38.568953 °	38.568953 °
				-121.362396 °	-121.362396 °
DWR ID	DWR_NA0001_04_s _ 2012_138				
Comment Code					
FE : Fence					
Inspector Comment					
03/16/2012 Wood privacy fence completely obstructs visibility and access.

03/16/2012 Wood privacy fence completely obstructs access and visibility.

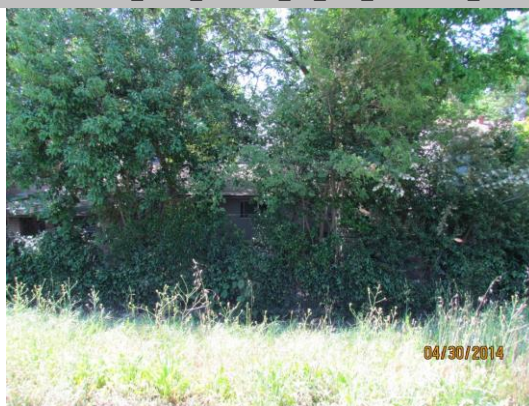
Photo 1 of 1 : SP_2016_NA0001_55_245_20160229_00188.jpg

LM Start	10.06	Rating **	U	Issue No.	245
LM End	10.06	Issue Type +	En	Location *	LS
Category	Earthen Levee			GPS Latitude/Longitude	
				Start	End
Item	Encroachments			38.569247 °	38.569247 °
				-121.361315 °	-121.361315 °
DWR ID	DWR_NA0001_04_s _ 2014_245				
Comment Code					
FE : Fence					
Inspector Comment					
Rod fence covered with vegetation within 10ft of levee toe.

View of the fence at the landside levee toe.

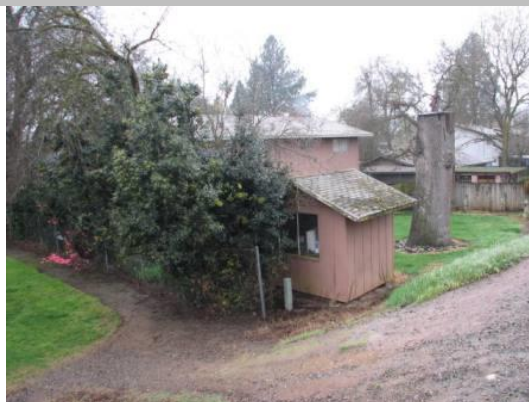
Photo 1 of 1 : SP_2016_NA0001_55_176_20160229_00153.jpg

LM Start	10.08	Rating **	U	Issue No.	176
LM End	10.08	Issue Type +	En	Location *	LS
Category	Earthen Levee			GPS Latitude/Longitude	
				Start	End
Item	Encroachments			38.569293 °	38.569293 °
				-121.361002 °	-121.361002 °
DWR ID	DWR_NA0001_04_s _ 2012_176				
Comment Code					
BU : Building					
Inspector Comment

03/16/2012 Wood structure within 15' of levee toe.

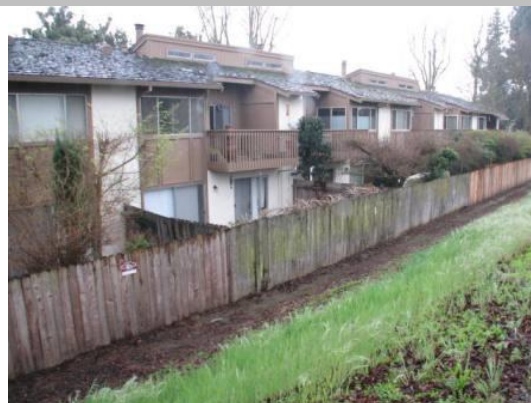
Photo 1 of 1 : SP_2016_NA0001_55_141_20160229_00120.jpg

LM Start	10.24	Rating **	U	Issue No.	141
LM End	10.27	Issue Type +	En	Location *	LS
Category	Earthen Levee			GPS Latitude/Longitude	
				Start	End
Item	Encroachments			38.569982 °	38.570118 °
				-121.358134 °	-121.357604 °
DWR ID	DWR_NA0001_04_s_2012_141				
Comment Code					
FE : Fence					
Inspector Comment					
Wooden fence behind six apartment units is within 10-ft of levee slope.

03/16/2012 Wood privacy fence completely obstructs access and visibility.

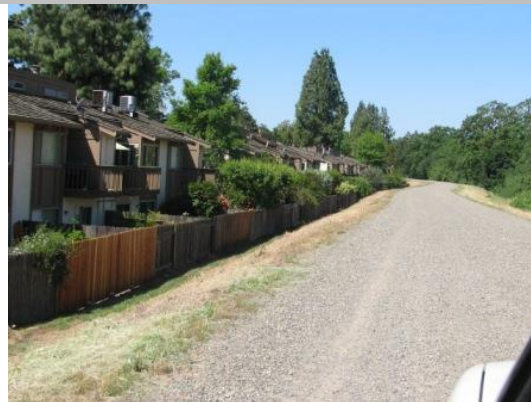
Photo 1 of 1 : SP_2016_NA0001_55_142_20160229_00121.jpg

LM Start	10.28	Rating **	U	Issue No.	142
LM End	10.30	Issue Type +	En	Location *	LS
Category	Earthen Levee			GPS Latitude/Longitude	
				Start	End
Item	Encroachments			38.570175 °	38.570229 °
				-121.357390 °	-121.357041 °
DWR ID	DWR_NA0001_04_s_2012_142				
Comment Code					
FE : Fence					
Inspector Comment					
Wooden fence behind six apartment units is within 10-ft of levee slope.

Wooden fence behind apartments within 10' of levee toe.

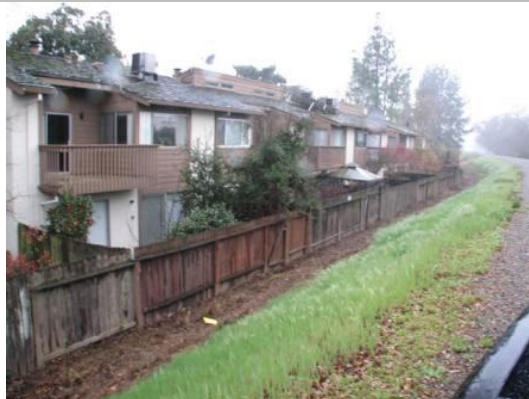
Photo 1 of 1 : SP_2016_NA0001_55_146_20160229_00125.jpg

LM Start	10.30	Rating **	U	Issue No.	146
LM End	10.32	Issue Type +	En	Location *	LS
Category	Earthen Levee			GPS Latitude/Longitude	
				Start	End
Item	Encroachments			38.570225 °	38.570245 °
				-121.357014 °	-121.356791 °
DWR ID	DWR_NA0001_04_s _ 2012_146				
Comment Code					
FE : Fence					
Inspector Comment					
Wooden fence behind 6 apartments.

03/16/2012 Wood privacy fence completely obstructs access and visibility.

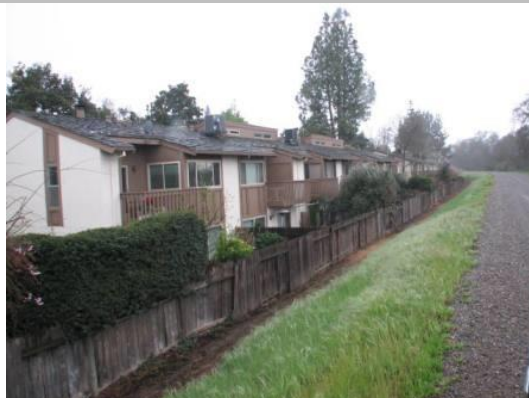
Photo 1 of 1 : SP_2016_NA0001_55_143_20160229_00122.jpg

LM Start	10.32	Rating **	U	Issue No.	143
LM End	10.34	Issue Type +	En	Location *	LS
Category	Earthen Levee			GPS Latitude/Longitude	
				Start	End
Item	Encroachments			38.570257 °	38.570297 °
				-121.356783 °	-121.356403 °
DWR ID	DWR_NA0001_04_s _ 2012_143				
Comment Code					
FE : Fence					
Inspector Comment					
Wooden fence behind six apartment units is within 10-ft of levee slope.

03/16/2012 Wood privacy fence completely obstructs access and visibility.

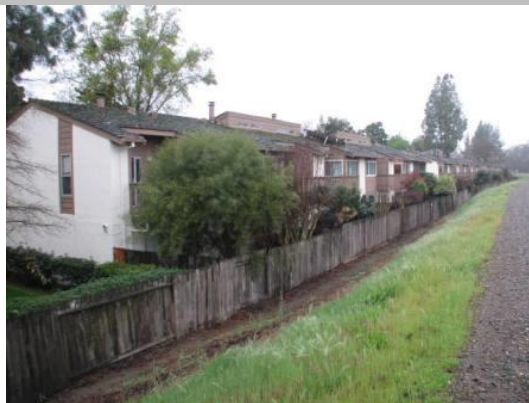
Photo 1 of 1 : SP_2016_NA0001_55_144_20160229_00123.jpg

LM Start	10.35	Rating **	U	Issue No.	144
LM End	10.37	Issue Type +	En	Location *	LS
Category	Earthen Levee			GPS Latitude/Longitude	
				Start	End
Item	Encroachments			38.570325 °	38.570397 °
				-121.356185 °	-121.355757 °
DWR ID	DWR_NA0001_04_s _ 2012_144				
Comment Code					
FE : Fence					
Inspector Comment					
Wooden fence behind six apartment units is within 10-ft of levee slope.

03/16/2012 Wood privacy fence completely obstructs access and visibility.

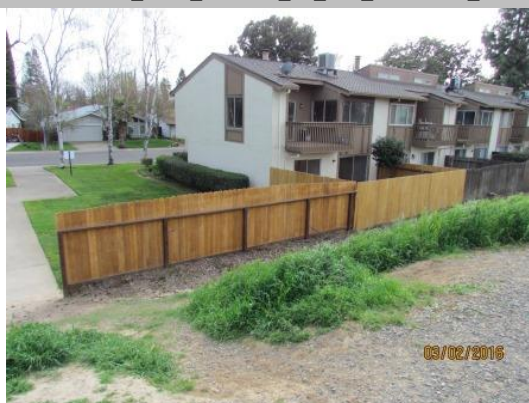
Photo 1 of 1 : SP_2016_NA0001_55_145_20160308_00245.jpg

LM Start	10.38	Rating **	U	Issue No.	145
LM End	10.41	Issue Type +	En	Location *	LS
Category	Earthen Levee			GPS Latitude/Longitude	
				Start	End
Item	Encroachments			38.570417 °	38.570500 °
				-121.355625 °	-121.355151 °
DWR ID	DWR_NA0001_04_s _ 2012_145				
Comment Code					
FE : Fence					
Inspector Comment					
Wooden fence behind six apartment units is within 10-ft of levee slope.

Wood privacy fence completely obstructs access and visibility.

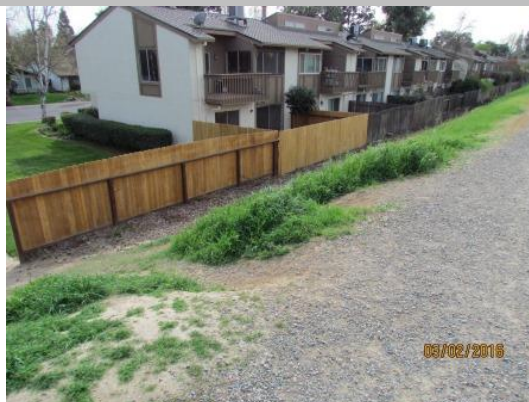
Photo 1 of 1 : SP_2016_NA0001_55_228_20160308_00244.jpg

LM Start	10.42	Rating **	A/W	Issue No.	228
LM End	10.42	Issue Type +	Ma	Location *	LS
Category	Earthen Levee			GPS Latitude/Longitude	
				Start	End
Item	Slope Stability			38.570536 °	38.570536 °
				-121.354957 °	-121.354957 °
DWR ID	DWR_NA0001_04_s _ 2016_228				
Comment Code					
S2 : Repair the levee slope damaged by foot traffic and prevent access where possible.					
Inspector Comment

View of the fence at the landside levee toe.

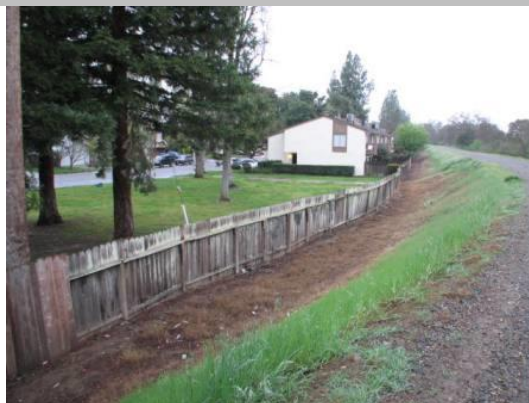
Photo 1 of 1 : SP_2016_NA0001_55_147_20160229_00126.jpg

LM Start	10.43	Rating **	U	Issue No.	147
LM End	10.43	Issue Type +	En	Location *	LS
Category	Earthen Levee			GPS Latitude/Longitude	
				Start	End
Item	Encroachments			38.570542 °	38.570542 °
				-121.354772 °	-121.354772 °
DWR ID	DWR_NA0001_04_s_2012_147				
Comment Code					
FE : Fence					
Inspector Comment					
Wooden privacy fence.

03/16/2012 Wood privacy fence completely obstructs access and visibility.

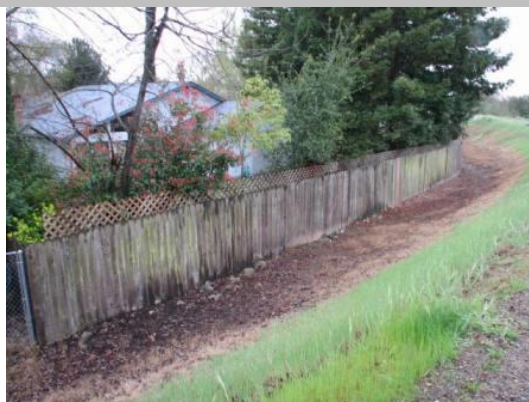
Photo 1 of 1 : SP_2016_NA0001_55_148_20160229_00127.jpg

LM Start	10.45	Rating **	U	Issue No.	148
LM End	10.45	Issue Type +	En	Location *	LS
Category	Earthen Levee			GPS Latitude/Longitude	
				Start	End
Item	Encroachments			38.570524 °	38.570524 °
				-121.354359 °	-121.354359 °
DWR ID	DWR_NA0001_04_s_2012_148				
Comment Code					
FE : Fence					
Inspector Comment					
Wooden privacy fence obstructs visibility and access.

03/16/2012 Wood privacy fence completely obstructs access and visibility.

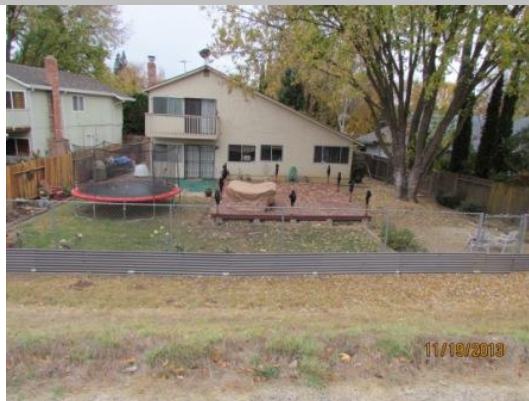
Photo 1 of 1 : SP_2016_NA0001_55_180_20160229_00157.jpg

LM Start	10.47	Rating **	M	Issue No.	180
LM End	10.47	Issue Type +	En	Location *	LS
Category	Earthen Levee			GPS Latitude/Longitude	
				Start	End
Item	Encroachments			38.570397 °	38.570397 °
				-121.354084 °	-121.354084 °
DWR ID	DWR_NA0001_04_s_2012_180				
Comment Code					
FE : Fence					
Inspector Comment					
Chainlink fence partially obstructs, currently visibility is unobstructed.

Chainlink fence is partially obstructing visibility and access.

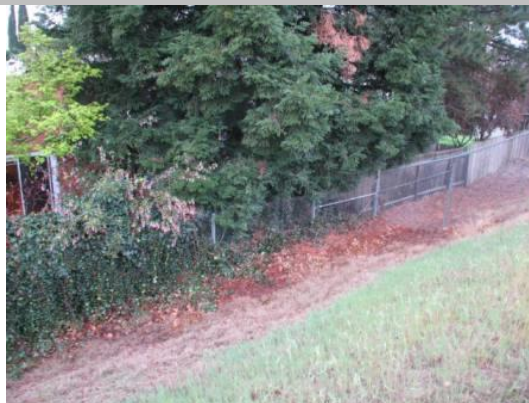
Photo 1 of 1 : SP_2016_NA0001_55_150_20160229_00129.jpg

LM Start	10.49	Rating **	U	Issue No.	150
LM End	10.49	Issue Type +	En	Location *	LS
Category	Earthen Levee			GPS Latitude/Longitude	
				Start	End
Item	Encroachments			38.570095 °	38.570095 °
				-121.353807 °	-121.353807 °
DWR ID	DWR_NA0001_04_s _ 2012_150				
Comment Code					
FE : Fence					
Inspector Comment					
Wooden privacy fence within 10-ft of levee toe.

03/16/2012 Wood privacy fence completely obstructs access and visibility.

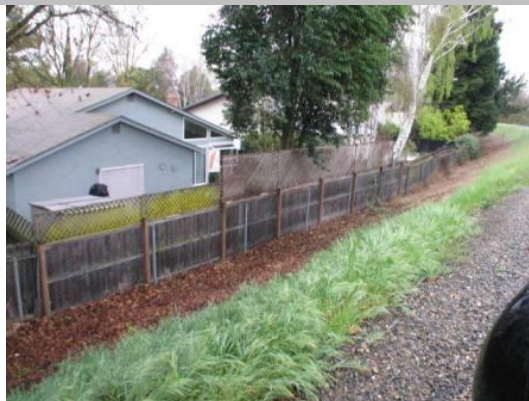
Photo 1 of 1 : SP_2016_NA0001_55_152_20160229_00131.jpg

LM Start	10.52	Rating **	U	Issue No.	152
LM End	10.52	Issue Type +	En	Location *	LS
Category	Earthen Levee			GPS Latitude/Longitude	
				Start	End
Item	Encroachments			38.569758 °	38.569758 °
				-121.353535 °	-121.353535 °
DWR ID	DWR_NA0001_04_s_2012_152				
Comment Code					
FE : Fence					
Inspector Comment					
Wooden privacy fence within 10-ft of levee toe.

03/16/2012 Wood privacy fence completely obstructs access and visibility.

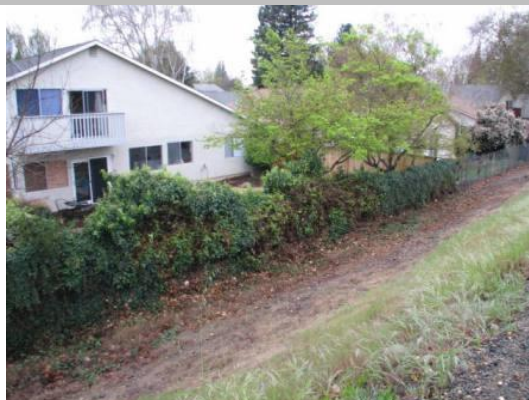
Photo 1 of 1 : SP_2016_NA0001_55_153_20160229_00132.jpg

LM Start	10.57	Rating **	U	Issue No.	153
LM End	10.57	Issue Type +	En	Location *	LS
Category	Earthen Levee			GPS Latitude/Longitude	
				Start	End
Item	Encroachments			38.569166 °	38.569166 °
				-121.353272 °	-121.353272 °
DWR ID	DWR_NA0001_04_s_2012_153				
Comment Code					
FE : Fence					
Inspector Comment					
Wooden privacy fence and ivy within 10-ft of levee toe.

03/16/2012 Wood privacy fence completely obstructs access and visibility.

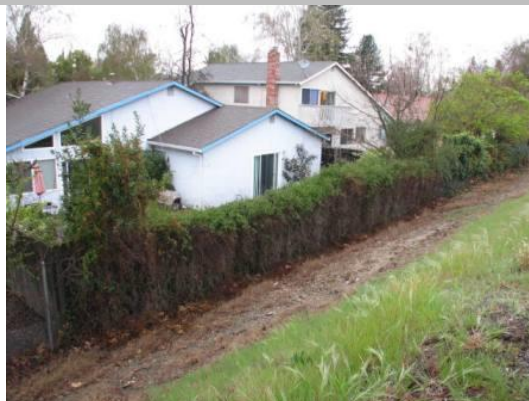
Photo 1 of 1 : SP_2016_NA0001_55_154_20160229_00133.jpg

LM Start	10.57	Rating **	U	Issue No.	154
LM End	10.57	Issue Type +	En	Location *	LS
Category	Earthen Levee			GPS Latitude/Longitude	
				Start	End
Item	Encroachments			38.569020 °	38.569020 °
				-121.353313 °	-121.353313 °
DWR ID	DWR_NA0001_04_s_2012_154				
Comment Code					
FE : Fence					
Inspector Comment					
Wooden privacy fence within 10-ft of levee toe.

03/16/2012 Wood privacy fence completely obstructs access and visibility.

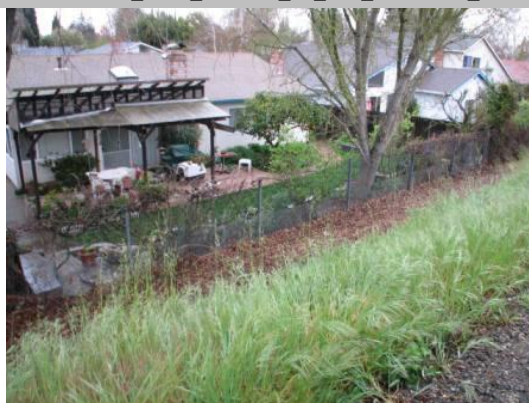
Photo 1 of 1 : SP_2016_NA0001_55_155_20160229_00134.jpg

LM Start	10.59	Rating **	M	Issue No.	155
LM End	10.59	Issue Type +	En	Location *	LS
Category	Earthen Levee			GPS Latitude/Longitude	
				Start	End
Item	Vegetation			38.568892 °	38.568892 °
				-121.353162 °	-121.353162 °
DWR ID	DWR_NA0001_04_s_2012_155				
Comment Code					
V6 : Landscaping					
Inspector Comment					
Trees and bushes are within 10-ft of the levee toe.

03/16/2012 Trees and bushes within 10' of levee toe.

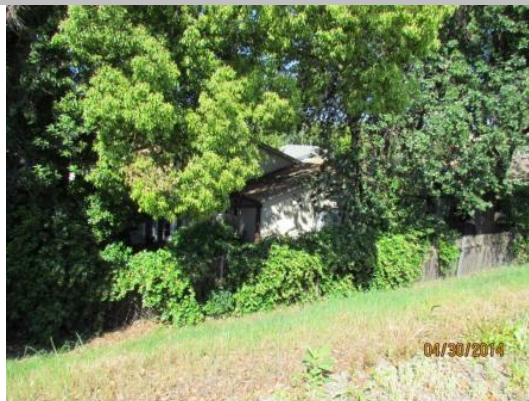
Photo 1 of 1 : SP_2016_NA0001_55_156_20160229_00135.jpg

LM Start	10.60	Rating **	U	Issue No.	156
LM End	10.60	Issue Type +	En	Location *	LS
Category	Earthen Levee			GPS Latitude/Longitude	
				Start	End
Item	Encroachments			38.568713 °	38.568713 °
				-121.353150 °	-121.353150 °
DWR ID	DWR_NA0001_04_s_2012_156				
Comment Code					
FE : Fence					
Inspector Comment					
Wooden privacy fence and landscaping within 10-ft of levee toe.

View of the fence at the landside levee toe obstructing visibility and access.

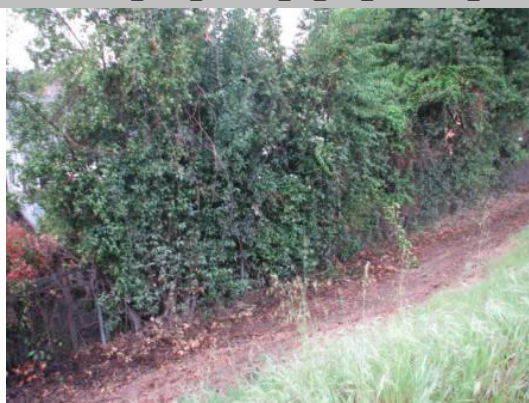
Photo 1 of 1 : SP_2016_NA0001_55_157_20160229_00136.jpg

LM Start	10.61	Rating **	M	Issue No.	157
LM End	10.61	Issue Type +	En	Location *	LS
Category	Earthen Levee			GPS Latitude/Longitude	
				Start	End
Item	Vegetation			38.568608 °	38.568608 °
				-121.353054 °	-121.353054 °
DWR ID	DWR_NA0001_04_s_2012_157				
Comment Code					
V6 : Landscaping					
Inspector Comment					
Tall hedge and vine on levee toe.

03/16/2012 Landscaping obstructs visibility

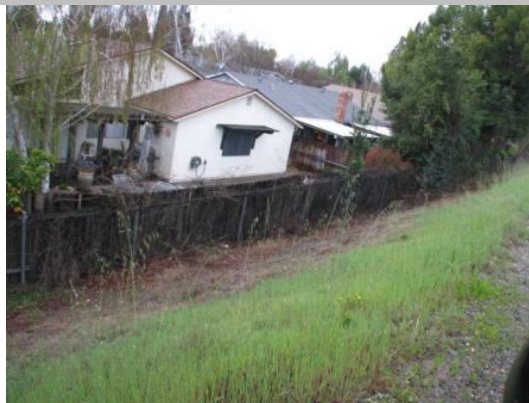
Photo 1 of 1 : SP_2016_NA0001_55_158_20160229_00137.jpg

LM Start	10.62	Rating **	U	Issue No.	158
LM End	10.62	Issue Type +	En	Location *	LS
Category	Earthen Levee			GPS Latitude/Longitude	
				Start	End
Item	Encroachments			38.568355 °	38.568355 °
				-121.353033 °	-121.353033 °
DWR ID	DWR_NA0001_04_s_2012_158				
Comment Code					
FE : Fence					
Inspector Comment					
Wooden privacy fence within 10-ft of levee toe.

03/16/2012 Wood privacy fence completely obstructs access and visibility.

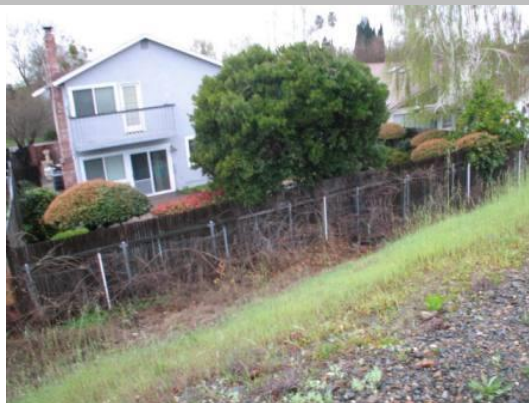
Photo 1 of 1 : SP_2016_NA0001_55_159_20160229_00138.jpg

LM Start	10.63	Rating **	U	Issue No.	159
LM End	10.63	Issue Type +	En	Location *	LS
Category	Earthen Levee			GPS Latitude/Longitude	
				Start	End
Item	Encroachments			38.568313 °	38.568313 °
				-121.352941 °	-121.352941 °
DWR ID	DWR_NA0001_04_s_2012_159				
Comment Code					
FE : Fence					
Inspector Comment					
Wooden privacy fence within 10-ft of levee toe.

03/16/2012 Wood privacy fence completely obstructs access and visibility.

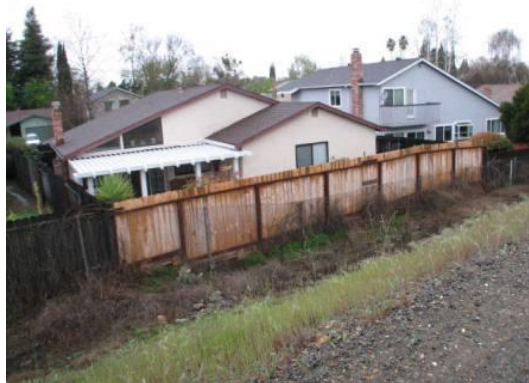
Photo 1 of 1 : SP_2016_NA0001_55_160_20160229_00139.jpg

LM Start	10.64	Rating **	U	Issue No.	160
LM End	10.64	Issue Type +	En	Location *	LS
Category	Earthen Levee			GPS Latitude/Longitude	
				Start	End
Item	Encroachments			38.568188 °	38.568188 °
				-121.352864 °	-121.352864 °
DWR ID	DWR_NA0001_04_f_2012_160				
Comment Code					
FE : Fence					
Inspector Comment					
Tall wooden privacy fence within 10-ft of levee toe.

03/16/2012 Wood privacy fence completely obstructs access and visibility.

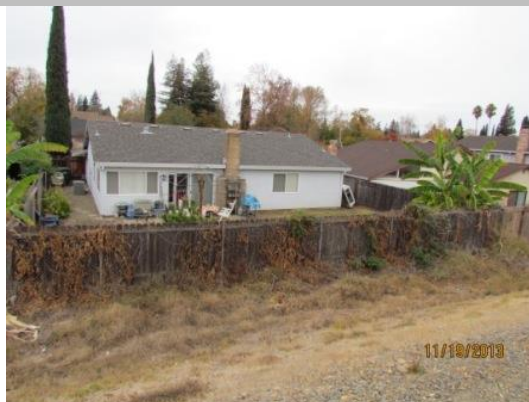
Photo 1 of 1 : SP_2016_NA0001_55_161_20160229_00140.jpg

LM Start	10.65	Rating **	U	Issue No.	161
LM End	10.65	Issue Type +	En	Location *	LS
Category	Earthen Levee			GPS Latitude/Longitude	
				Start	End
Item	Encroachments			38.568058 °	38.568058 °
				-121.352785 °	-121.352785 °
DWR ID	DWR_NA0001_04_s_2012_161				
Comment Code					
FE : Fence					
Inspector Comment					
Wooden privacy fence and vine within 10-ft of levee toe.

View of wood privacy fence completely obstructing access and visibility.

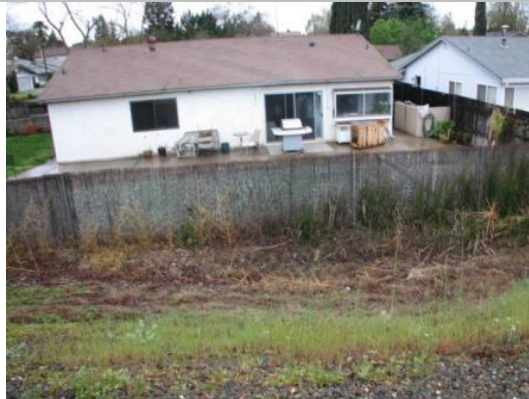
Photo 1 of 1 : SP_2016_NA0001_55_179_20160229_00156.jpg

LM Start	10.66	Rating **	U	Issue No.	179
LM End	10.66	Issue Type +	En	Location *	LS
Category	Earthen Levee			GPS Latitude/Longitude	
				Start	End
Item	Encroachments			38.567917 °	38.567917 °
				-121.352698 °	-121.352698 °
DWR ID	DWR_NA0001_04_s_2012_179				
Comment Code					
FE : Fence					
Inspector Comment					
Chainlink fence with bamboo mats prevent visibility.

03/16/2012 Bamboo panels on chainlink fence completely obstruct visibility.

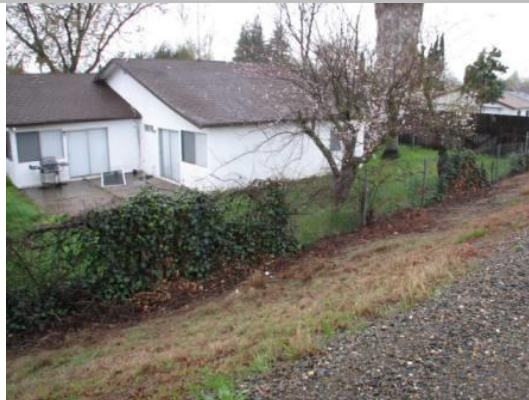
Photo 1 of 1 : SP_2016_NA0001_55_178_20160229_00155.jpg

LM Start	10.68	Rating **	M	Issue No.	178
LM End	10.68	Issue Type +	En	Location *	LS
Category	Earthen Levee			GPS Latitude/Longitude	
				Start	End
Item	Encroachments			38.567552 °	38.567552 °
				-121.352500 °	-121.352500 °
DWR ID	DWR_NA0001_04_s_2012_178				
Comment Code					
FE : Fence					
Inspector Comment					
Chainlink fence

03/16/2012 Chainlink fence partially blocks visibility.

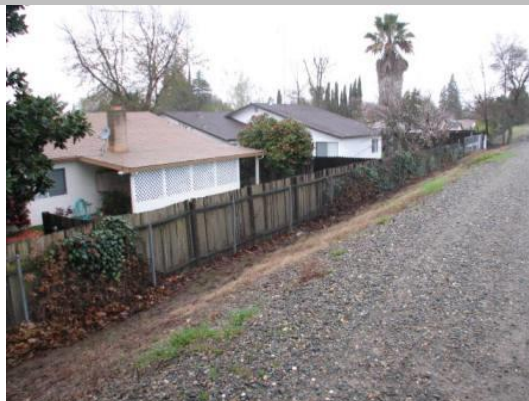
Photo 1 of 1 : SP_2016_NA0001_55_162_20160229_00141.jpg

LM Start	10.70	Rating **	U	Issue No.	162
LM End	10.70	Issue Type +	En	Location *	LS
Category	Earthen Levee			GPS Latitude/Longitude	
				Start	End
Item	Encroachments			38.567402 °	38.567402 °
				-121.352415 °	-121.352415 °
DWR ID	DWR_NA0001_04_s _ 2012_162				
Comment Code					
FE : Fence					
Inspector Comment					
Wooden privacy fence within 10-ft of levee toe.

03/16/2012 Wood privacy fence completely obstructs access and visibility.

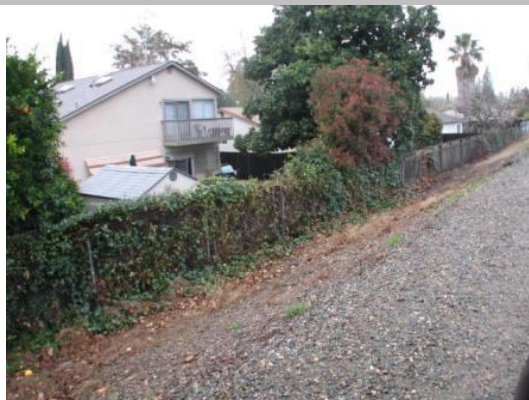
Photo 1 of 1 : SP_2016_NA0001_55_163_20160229_00142.jpg

LM Start	10.71	Rating **	U	Issue No.	163
LM End	10.71	Issue Type +	En	Location *	LS
Category	Earthen Levee			GPS Latitude/Longitude	
				Start	End
Item	Encroachments			38.567250 °	38.567250 °
				-121.352341 °	-121.352341 °
DWR ID	DWR_NA0001_04_s _ 2012_163				
Comment Code					
FE : Fence					
Inspector Comment					
Wooden privacy fence and landscaping within 10-ft of levee toe.

03/16/2012 Wood privacy fence completely obstructs access and visibility.

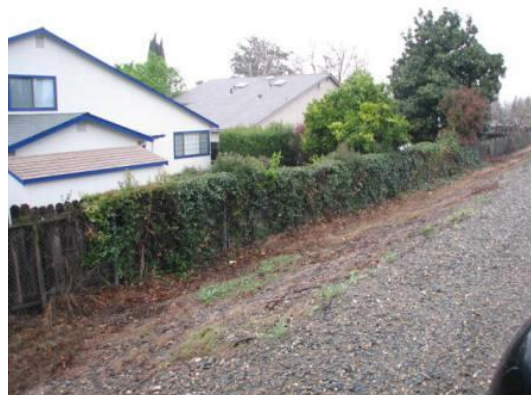
Photo 1 of 1 : SP_2016_NA0001_55_172_20160229_00150.jpg

LM Start	10.72	Rating **	U	Issue No.	172
LM End	10.72	Issue Type +	En	Location *	LS
Category	Earthen Levee			GPS Latitude/Longitude	
				Start	End
Item	Encroachments			38.567008 °	38.567008 °
				-121.352226 °	-121.352226 °
DWR ID	DWR_NA0001_04_s_2012_172				
Comment Code					
FE : Fence					
Inspector Comment					
Wooden privacy fence.

03/16/2012 Wood privacy fence completely obstructs access and visibility.

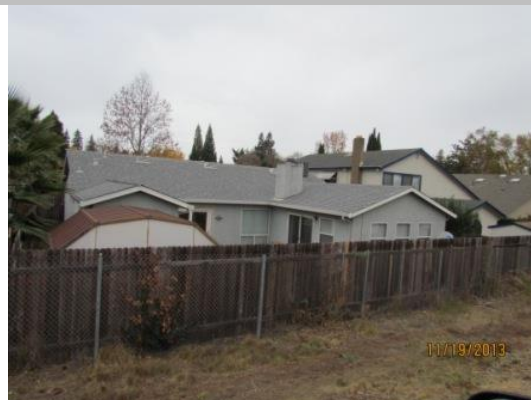
Photo 1 of 1 : SP_2016_NA0001_55_170_20160229_00148.jpg

LM Start	10.73	Rating **	U	Issue No.	170
LM End	10.73	Issue Type +	En	Location *	LS
Category	Earthen Levee			GPS Latitude/Longitude	
				Start	End
Item	Encroachments			38.566981 °	38.566981 °
				-121.352213 °	-121.352213 °
DWR ID	DWR_NA0001_04_f_2012_170				
Comment Code					
FE : Fence					
Inspector Comment					
Wooden privacy fence within 10-ft of levee toe.

View of the fence obstructing visibility and access.

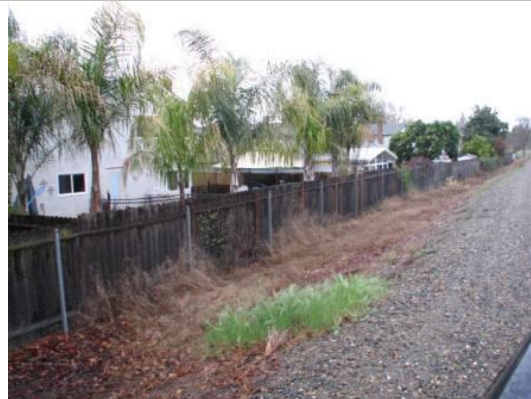
Photo 1 of 1 : SP_2016_NA0001_55_166_20160229_00144.jpg

LM Start	10.75	Rating **	U	Issue No.	166
LM End	10.75	Issue Type +	En	Location *	LS
Category	Earthen Levee			GPS Latitude/Longitude	
				Start	End
Item	Encroachments			38.566705 °	38.566705 °
				-121.352063 °	-121.352063 °
DWR ID	DWR_NA0001_04_s _ 2012_166				
Comment Code					
FE : Fence					
Inspector Comment					
Wooden privacy fence within 10-ft of levee toe.

03/16/2012 Wood privacy fence completely obstructs access and visibility.

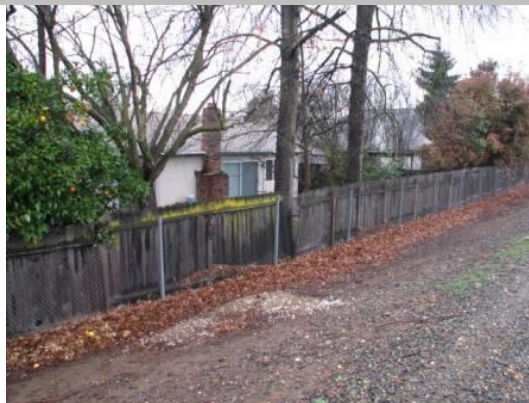
Photo 1 of 1 : SP_2016_NA0001_55_169_20160229_00147.jpg

LM Start	10.77	Rating **	U	Issue No.	169
LM End	10.77	Issue Type +	En	Location *	LS
Category	Earthen Levee			GPS Latitude/Longitude	
				Start	End
Item	Encroachments			38.566399 °	38.566399 °
				-121.351931 °	-121.351931 °
DWR ID	DWR_NA0001_04_s _ 2012_169				
Comment Code					
FE : Fence					
Inspector Comment					
Wooden privacy fence within 10-ft of levee toe.

03/16/2012 Wood privacy fence completely obstructs access and visibility.

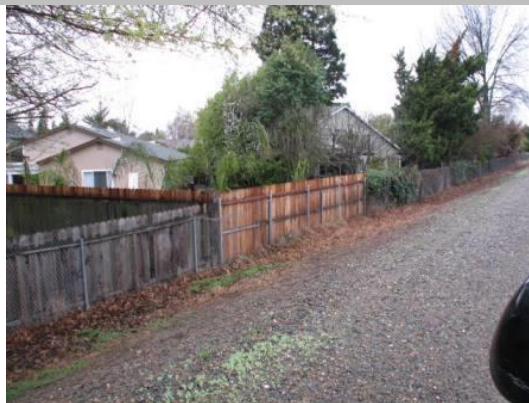
Photo 1 of 1 : SP_2016_NA0001_55_165_20160229_00143.jpg

LM Start	10.80	Rating **	U	Issue No.	165
LM End	10.80	Issue Type +	En	Location *	LS
Category	Earthen Levee			GPS Latitude/Longitude	
				Start	End
Item	Encroachments			38.566044 °	38.566044 °
				-121.351747 °	-121.351747 °
DWR ID	DWR_NA0001_04_s_2012_165				
Comment Code					
FE : Fence					
Inspector Comment					
Wooden privacy fence within 10-ft of levee toe.

03/16/2012 Wood privacy fence completely obstructs access and visibility.

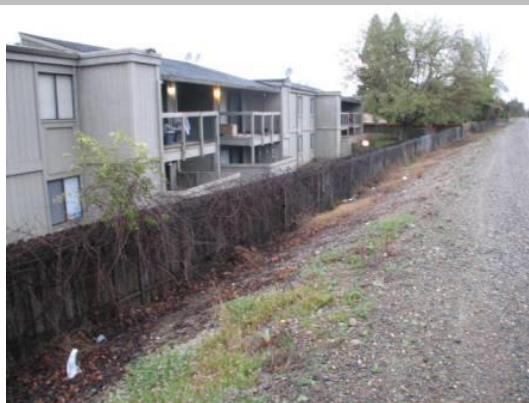
Photo 1 of 1 : SP_2016_NA0001_55_168_20160229_00146.jpg

LM Start	10.81	Rating **	U	Issue No.	168
LM End	10.83	Issue Type +	En	Location *	LS
Category	Earthen Levee			GPS Latitude/Longitude	
				Start	End
Item	Encroachments			38.565917 °	38.565646 °
				-121.351682 °	-121.351532 °
DWR ID	DWR_NA0001_04_s_2012_168				
Comment Code					
FE : Fence					
Inspector Comment					
Wooden privacy fence within 10-ft of levee toe.

03/16/2012 Wood privacy fence completely obstructs access and visibility.

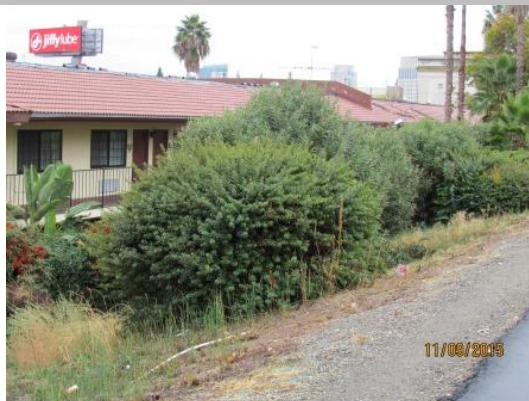
Photo 1 of 1 : SP_2016_NA0001_56_2_20160229_00001.jpg

LM Start	0.10	Rating **	U	Issue No.	2
LM End	0.17	Issue Type +	En	Location *	LS
Category	Earthen Levee			GPS Latitude/Longitude	
				Start	End
Item	Vegetation			38.595044 °	38.594117 °
				-121.506497 °	-121.506377 °
DWR ID	DWR_NA0001_05_s_2012_2				
Comment Code					
V6 : Landscaping					
Inspector Comment					
Landcaping behind Best Western.

View of the landscaping on the landside levee slope obstructing visibility and access.

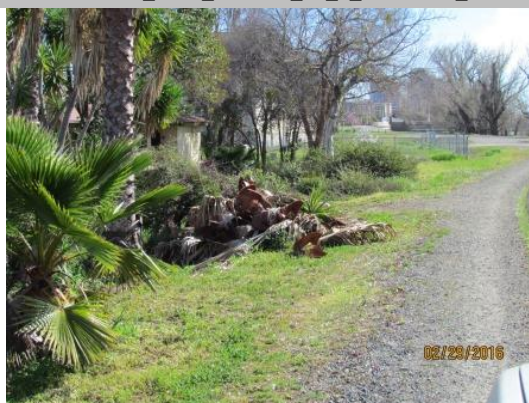
Photo 1 of 1 : SP_2016_NA0001_56_1_20160307_00003.jpg

LM Start	0.13	Rating **	M	Issue No.	1
LM End	0.13	Issue Type +	Ma	Location *	LS
Category	Earthen Levee			GPS Latitude/Longitude	
				Start	End
Item	Encroachments			38.594631 °	38.594631 °
				-121.506382 °	-121.506382 °
DWR ID	DWR_NA0001_05_s_2016_1				
Comment Code					
PR : Prunings					
Inspector Comment

View of the prunings on the landside levee slope.

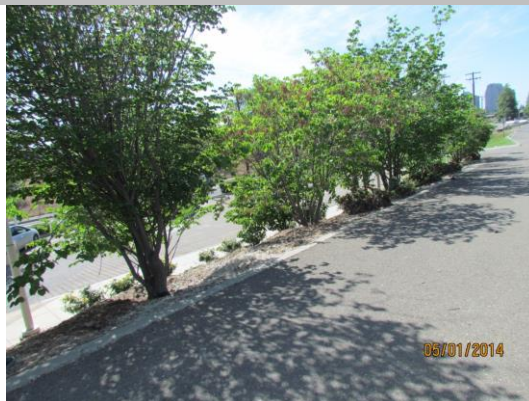
Photo 1 of 1 : SP_2016_NA0001_56_5_20160229_00002.jpg

LM Start	0.27	Rating **	M	Issue No.	5
LM End	0.35	Issue Type +	En	Location *	LS
Category	Earthen Levee			GPS Latitude/Longitude	
				Start	End
Item	Vegetation			38.592630 °	38.591517 °
				-121.505850 °	-121.505447 °
DWR ID	DWR_NA0001_05_s _ 2012_5				
Comment Code					
V6 : Landscaping					
Inspector Comment					
Landscaping at City intake facility.

View of the landscaping on the landside levee slope at the City intake facility.

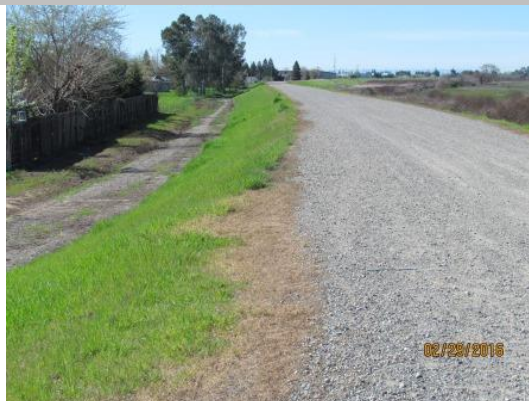
Photo 1 of 1 : SP_2016_NA0001_57_8_20160307_00007.jpg

LM Start	0.05	Rating **	A	Issue No.	8
LM End	0.96	Issue Type +	Ma	Location *	LS
Category	Earthen Levee			GPS Latitude/Longitude	
				Start	End
Item	Vegetation			38.657339 °	38.662134 °
				-121.473793 °	-121.458451 °
DWR ID	DWR_NA0001_06_s _ 2016_8				
Comment Code					
V1 : Control annual grass and weeds on the levee slopes and easements.					
Inspector Comment

View of the vegetation on the landside levee slope, looking downstream.

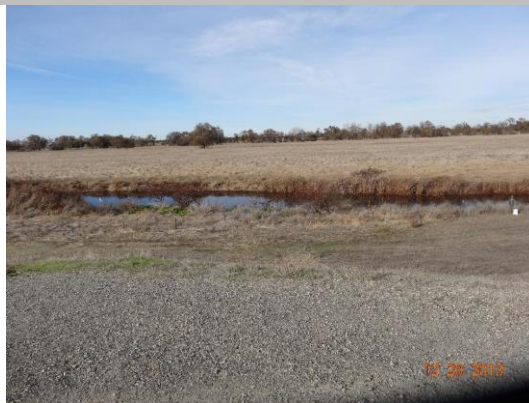
Photo 1 of 2 : UCIP_SP_2016_30706_56559.jpg

LM Start	0.75	Rating **	M	Issue No.	10
LM End	0.75	Issue Type +	En	Location *	LS
Category	Supplemental			GPS Latitude/Longitude	
				Start	End
Item	DWR UCIP Field Study			38.660518 °	38.660518 °
				-121.461826 °	-121.461826 °
DWR ID					
Comment Code					
Inspector Comment					
FS_ID:30706 DS_ID:24812 EP_NO: N/A Repair Type: Non-Urgent Crossing Status: Indicator Found UCIP Comments: Unable to confirm if line goes through levee or along landward slope. No permit found. FIELD_STRUCT_DESC: Storm drain manhole located on landside (LS). FS Date: 12/20/2013

View of waterward side.

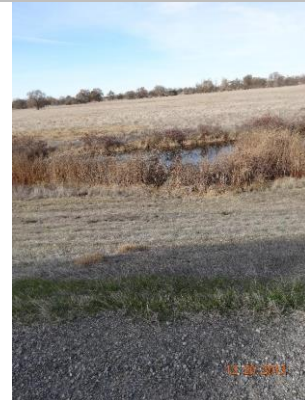
Photo 1 of 2 : UCIP_SP_2016_29223_54002.jpg

Comment Code					
Inspector Comment					
FS_ID:29223 DS_ID:24354 EP_NO: N/A Repair Type: Non-Urgent Crossing Status: Indicator Found UCIP Comments: Unable to find CM riser and flap gate on waterward end--need to contact owner to determine status of crossing. Manhole found on landward side however unable to determine if manhole is part of this crossing. FIELD_STRUCT_DESC: 24-inch pipe through the levee, 12.5 feet below the crown. Two corrugated metal (CM) cutoff walls around pipe. Slide gate in CM riser and flap gate at waterside (WS) end. Concrete headwalls on both ends. (USACE-1959). This entry matches the Drainage or Irrigation Structure referenced in O&M manual (Station 440+50). FS Date: 12/20/2013

View of waterward side--no evidence of crossing.

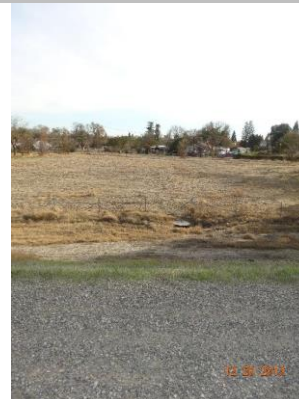
Photo 2 of 2 : UCIP_SP_2016_29223_54001.jpg

Comment Code						
Inspector Comment						
FS_ID:29223						
DS_ID:24354						
EP_NO: N/A						
Repair Type: Non-Urgent						
Crossing Status: Indicator Found						
UCIP Comments: Unable to find CM riser and flap gate on waterward end--need to contact owner to determine status of crossing. Manhole found on landward side however unable to determine if manhole is part of this crossing.						
FIELD_STRUCT_DESC: 24-inch pipe through the levee, 12.5 feet below the crown. Two corrugated metal (CM) cutoff walls around pipe. Slide gate in CM riser and flap gate at waterside (WS) end. Concrete headwalls on both ends. (USACE-1959). This entry matches the Drainage or Irrigation Structure referenced in O&M manual (Station 440+50).						
FS Date: 12/20/2013

View of landward side--manhole on landward toe.

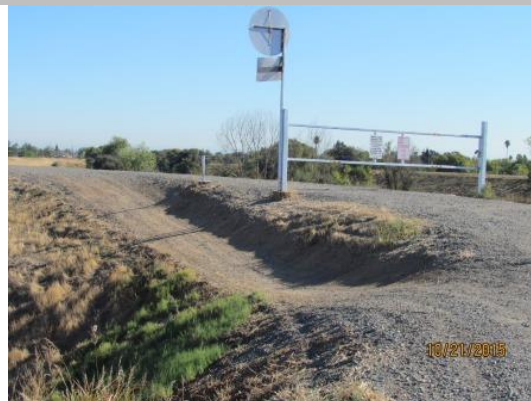
Photo 1 of 1 : SP_2016_NA0001_58_38_20160229_00028.jpg

LM Start	0.04	Rating **	M	Issue No.	38
LM End	0.04	Issue Type +	Ma	Location *	LS
Category	Earthen Levee			GPS Latitude/Longitude	
				Start	End
Item	Slope Stability			38.620569 °	38.620569 °
				-121.467117 °	-121.467117 °
DWR ID	DWR_NA0001_07_f_2015_38				
Comment Code					
S3 : Repair the levee slope damaged by vehicle traffic and prevent access where possible.					
Inspector Comment

View of the landside levee slope damaged by motorized traffic.

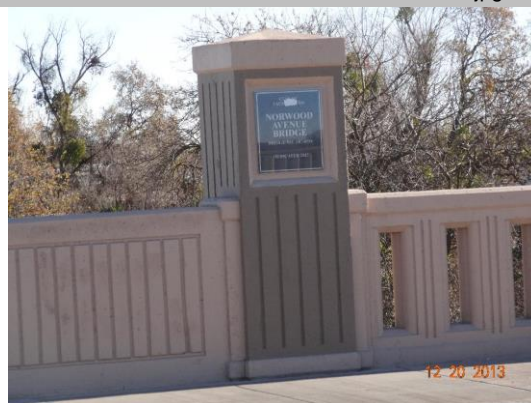
Photo 1 of 2 : UCIP_SP_2016_29237_54061.jpg

LM Start	0.71	Rating **	U	Issue No.	46
LM End	0.71	Issue Type +	En	Location *	LS
Category	Supplemental			GPS Latitude/Longitude	
				Start	End
Item	DWR UCIP Field Study			38.624843 °	38.624843 °
				-121.457097 °	-121.457097 °
DWR ID					
Comment Code					
Inspector Comment					
FS_ID:29237 DS_ID:24363 EP_NO: 3417 Repair Type: Urgent Crossing Status: Found UCIP Comments: Missing gas line markers -- need to contact owner to determine status. FIELD_STRUCT_DESC: *REMOVED* 4-inch steel gas line through the levee, 2.0 feet below the crown. Corrugated metal (CM) cutoff wall around pipe at center of levee. (Permit No. 3417-1961) Landscaping and staircase on landside (LS) slope added under Permit No. 3510 (1978), but was removed in 1994. FS Date: 12/20/2013

Norwood Avenue Bridge

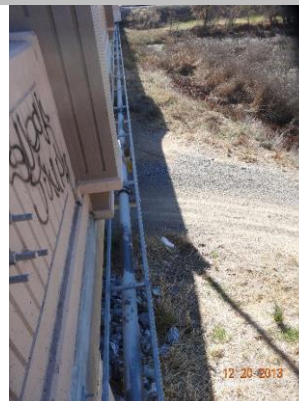
Photo 2 of 2 : UCIP_SP_2016_29237_54062.jpg

LM Start	0.71	Rating **	U	Issue No.	46 (cont)	
LM End	0.71	Issue Type +	En	Location *	LS	
Category	Supplemental			GPS Latitude/Longitude		
				Start		End
Item	DWR UCIP Field Study			38.624843 °		38.624843 °
				-121.457097 °		-121.457097 °
DWR ID						
Comment Code						
Inspector Comment						
FS_ID:29237						
DS_ID:24363						
EP_NO: 3417						
Repair Type: Urgent						
Crossing Status: Found						
UCIP Comments: Missing gas line markers -- need to contact owner to determine status.						
FIELD_STRUCT_DESC: *REMOVED* 4-inch steel gas line through the levee, 2.0 feet below the crown. Corrugated metal (CM) cutoff wall around pipe at center of levee. (Permit No. 3417-1961) Landscaping and staircase on landside (LS) slope added under Permit No. 3510 (1978), but was removed in 1994.						
FS Date: 12/20/2013

View of pipe attached to bridge.

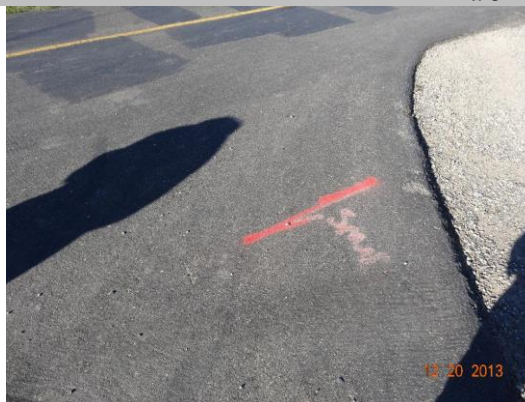
Photo 1 of 2 : UCIP_SP_2016_40803_48512.jpg

LM Start	1.24	Rating **	M	Issue No.	48
LM End	1.24	Issue Type +	En	Location *	LS
Category	Supplemental			GPS Latitude/Longitude	
				Start	End
Item	DWR UCIP Field Study			38.625785 °	38.625785 °
				-121.447464 °	-121.447464 °
DWR ID					
Comment Code					
Inspector Comment					
FS_ID:40803 DS_ID:24447 EP_NO: 16466 Repair Type: Non-Urgent Crossing Status: Found UCIP Comments: Need to contact owner to determine if crossings are at this location are associated with Permit number 16466--unable to confirm crossings. FIELD_STRUCT_DESC: Two 6-inch and one 2-inch concrete encased steel utility conduits through the levee, all approximately 2.0 feet below the crown. Manhole on the levee crown. (Permit No. 16466-1995) FS Date: 12/20/2013

Underground Service Alert (USA) marking present on pavement however, unable to verify crossings.

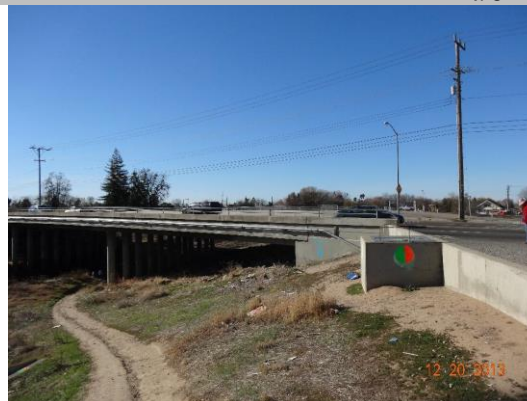
Photo 1 of 2 : UCIP_SP_2016_31273_57261.jpg

LM Start	1.33	Rating **	U	Issue No.	47
LM End	1.33	Issue Type +	En	Location *	LS
Category	Supplemental			GPS Latitude/Longitude	
				Start	End
Item	DWR UCIP Field Study			38.626296 °	38.626296 °
				-121.446038 °	-121.446038 °
DWR ID					
Comment Code					
Inspector Comment					
FS_ID:31273					
DS_ID:24443					
EP_NO: 15152					
Repair Type: Urgent					
Crossing Status: Indicator Found					
UCIP Comments: Unable to confirm if crossing is the same one authorized through permit.					
FIELD_STRUCT_DESC: 4-inch steel gas main through the levee, 2.5 feet below the crown. Vent on the waterside (WS) shoulder. (Permit No. 15152-1989)					
FS Date: 12/20/2013

Crossing attached to upstream face of bridge.

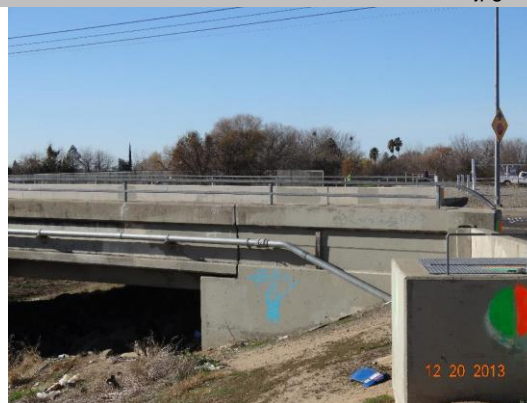
Photo 2 of 2 : UCIP_SP_2016_31273_57260.jpg

Close up view of crossing through levee.

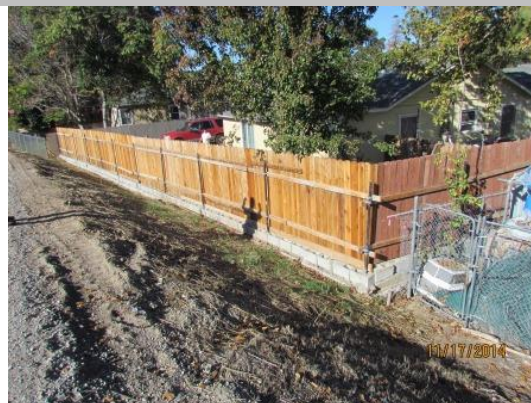
Photo 1 of 1 : SP_2016_NA0001_58_43_20160229_00031.jpg

LM Start	1.53	Rating **	U	Issue No.	43
LM End	1.54	Issue Type +	En	Location *	LS
Category	Earthen Levee			GPS Latitude/Longitude	
				Start	End
Item	Encroachments			38.627675 °	38.627718 °
				-121.442874 °	-121.442631 °
DWR ID	DWR_NA0001_07_s_2014_43				
Comment Code					
FE : Fence					
Inspector Comment					
New fence constructed on the property line with 18 inch CMU block base.

View of a fence at the landside levee toe obstructing visibility and access.

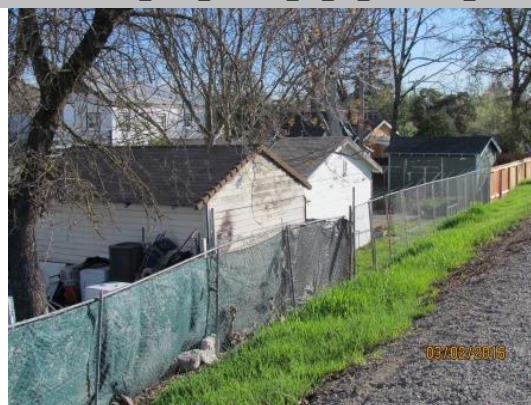
Photo 1 of 1 : SP_2016_NA0001_58_30_20160308_00048.jpg

LM Start	1.55	Rating **	U	Issue No.	30
LM End	1.55	Issue Type +	En	Location *	LS
Category	Earthen Levee			GPS Latitude/Longitude	
				Start	End
Item	Encroachments			38.627743 °	38.627743 °
				-121.442526 °	-121.442526 °
DWR ID	DWR_NA0001_07_s_2012_30				
Comment Code					
BU : Building					
Inspector Comment					
Large side building is within 10-ft of the levee toe.

View of the building at the landside levee toe.

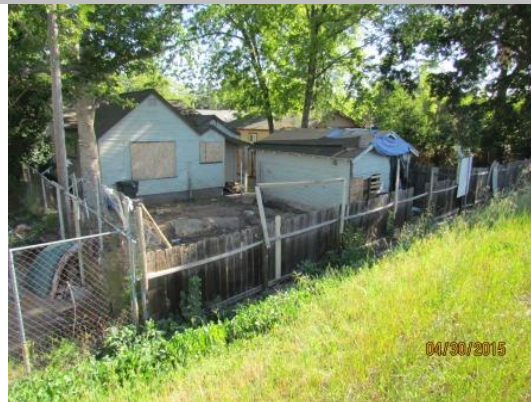
Photo 1 of 4 : SP_2016_NA0001_58_3_20160229_00002.jpg

LM Start	1.57	Rating **	U	Issue No.	3
LM End	1.57	Issue Type +	En	Location *	LS
Category	Earthen Levee			GPS Latitude/Longitude	
				Start	End
Item	Encroachments			38.627768 °	38.627768 °
				-121.442185 °	-121.442185 °
DWR ID	DWR_NA0001_07_s_2012_3				
Comment Code					
FE : Fence					
Inspector Comment					
Wooden privacy fence is within 10-ft of the levee toe.

Wooden privacy fence is constructed at the landside levee toe.
